14369 Ludlam Trail Corridor

SW 80th Street to 400' North of NW 7th Street

APPENDIX C
Phase I ESA

Ludlam Corridor Property
Former 1-Mile Railroad Corridor
Miami, Miami-Dade County, Florida

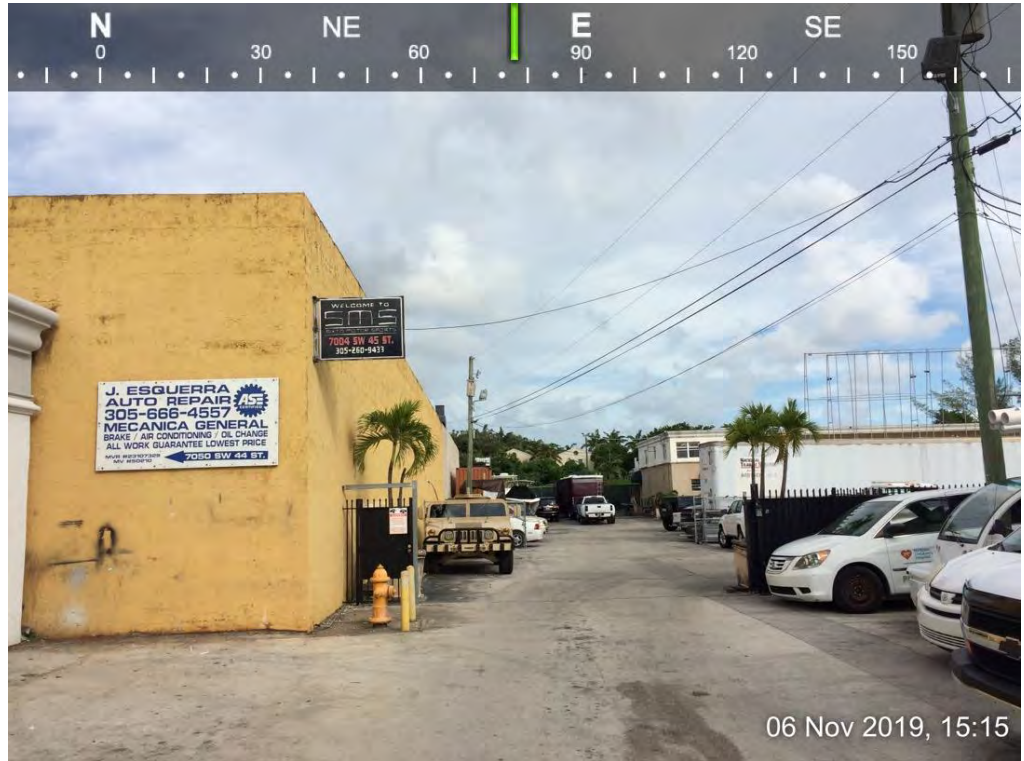
DESCRIPTION:
Caused Roofing Corp
Current use: Site is not in use and is currently being auto shop
(N1)

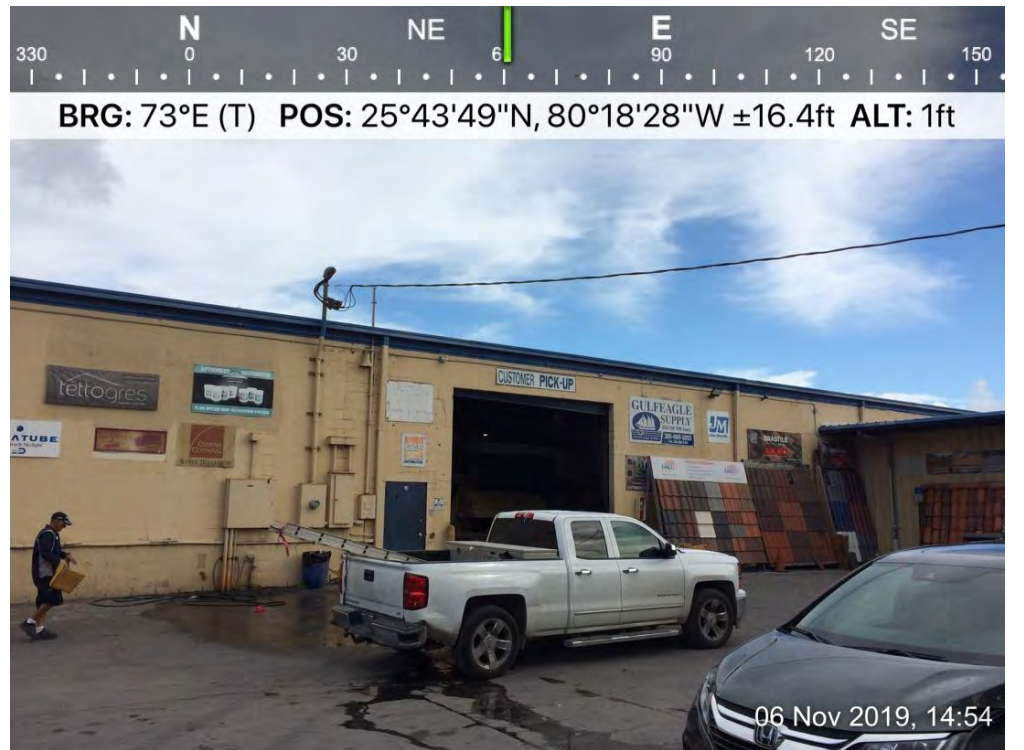
Photo No.
2

DESCRIPTION:
Gulfside Supply Inc.
Current use: Site is not in use and is currently being turned into a commercial roofing supply store
(N2)

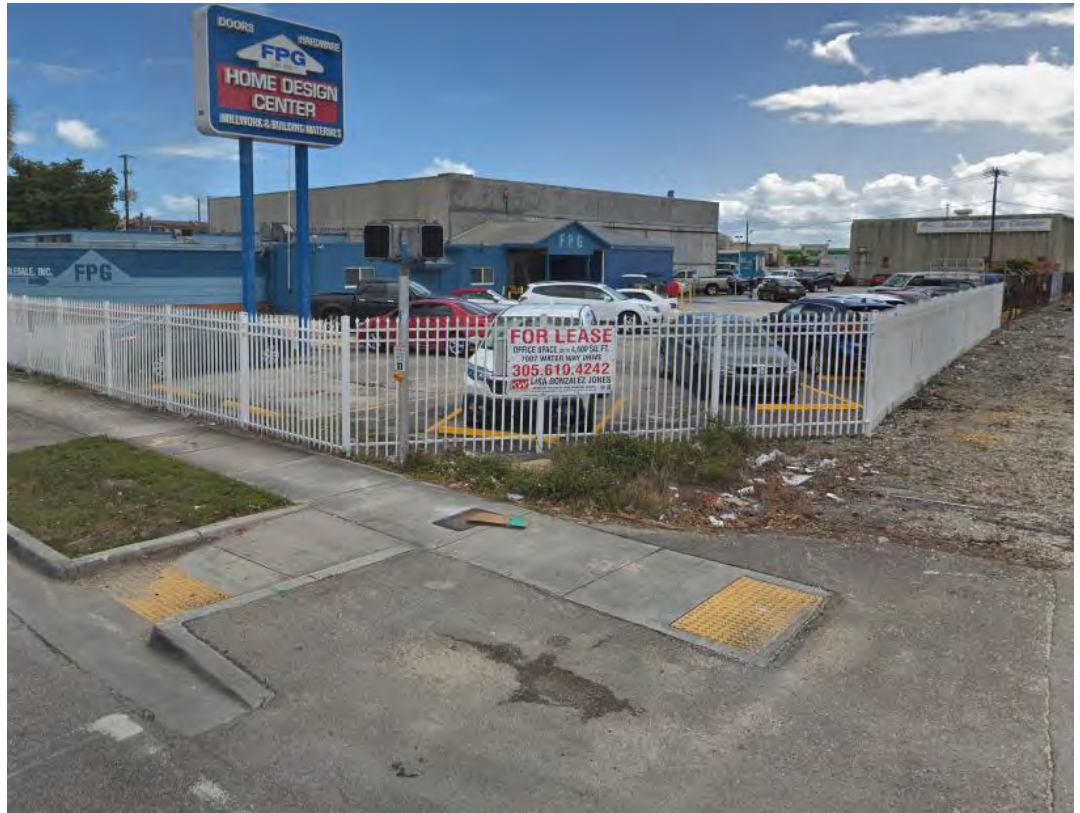
Photo No. 7 Date: 11/06/2019

DESCRIPTION:
Gold Coast Oil Corp
Current use: FPG Home design Center
(L1)

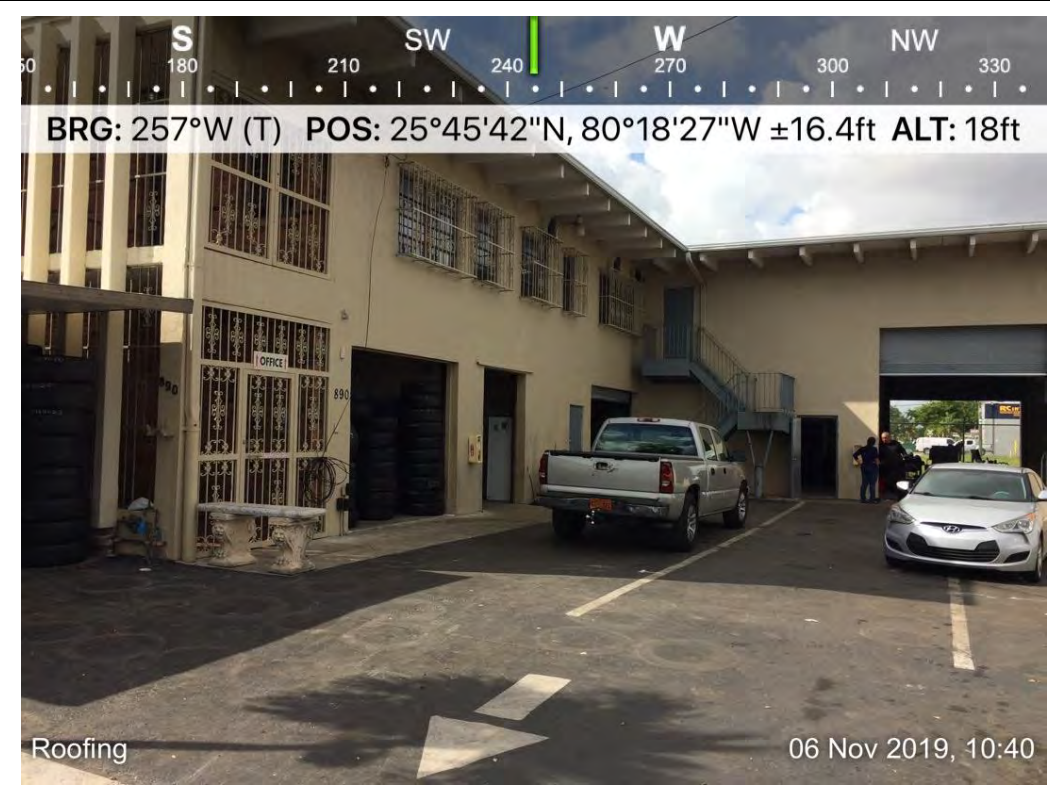
Photo No. 8 Date: 11/06/2019

DESCRIPTION:
Al Springer Roofing
Current use: Site is not in use and is currently being turned into a tire shop
(L2)
