Biological Assessment and Mitigation Analysis of the Airport West Site

Folio Nos. 30-2902-000-0010 & 30-2903-000-0010

Department of Regulatory and Economic Resources
Division of Environmental Resources Management

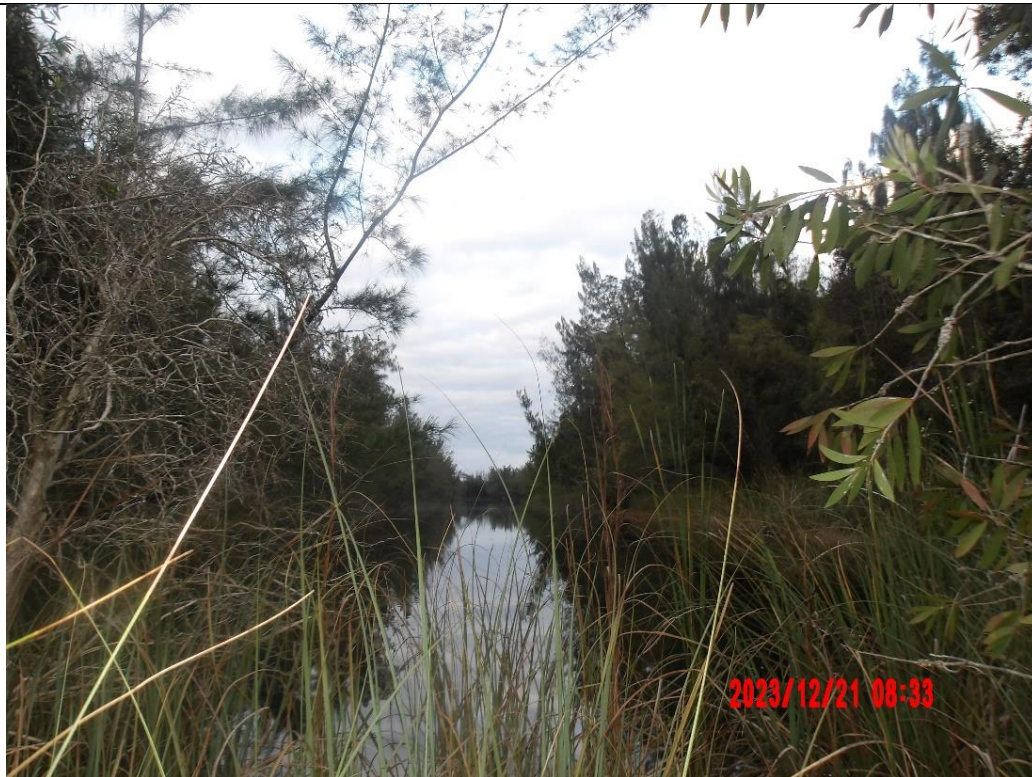
Photo 1

Description 1: View of open water area. No wading birds were seen in this area. Photo taken at Point B facing west.

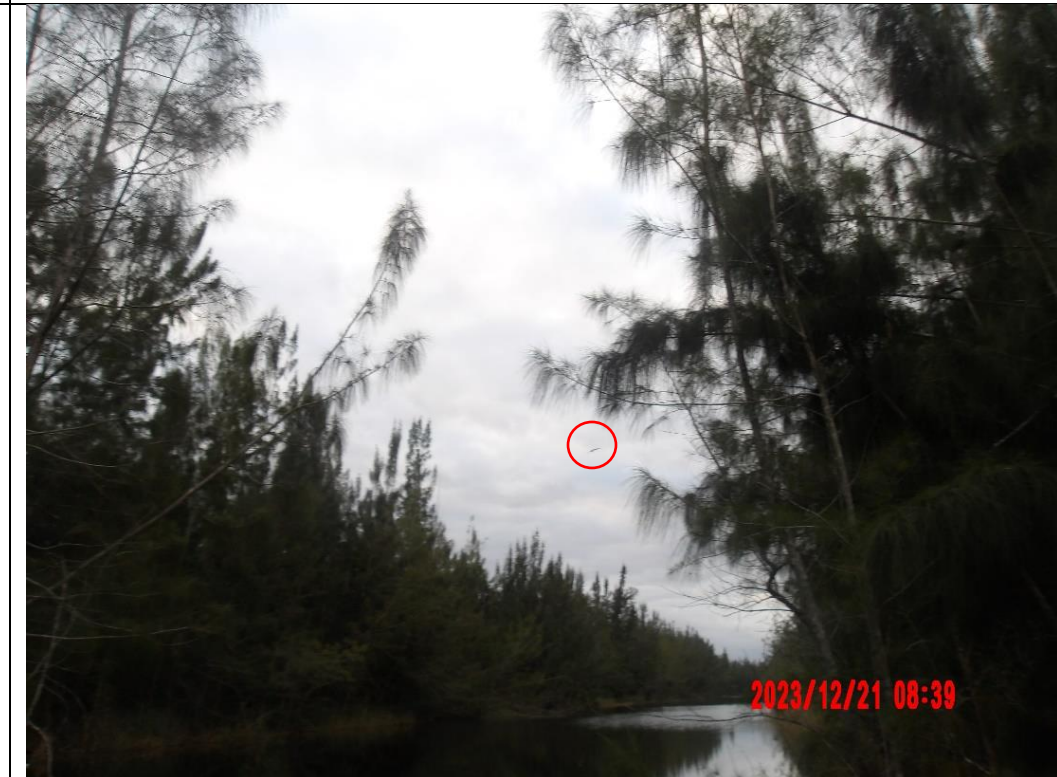
Photo 2

Description 2: View of *Pandion haliaetus* (osprey) (indicated by red circle) flying over open water area. Photo taken at Point C facing south.

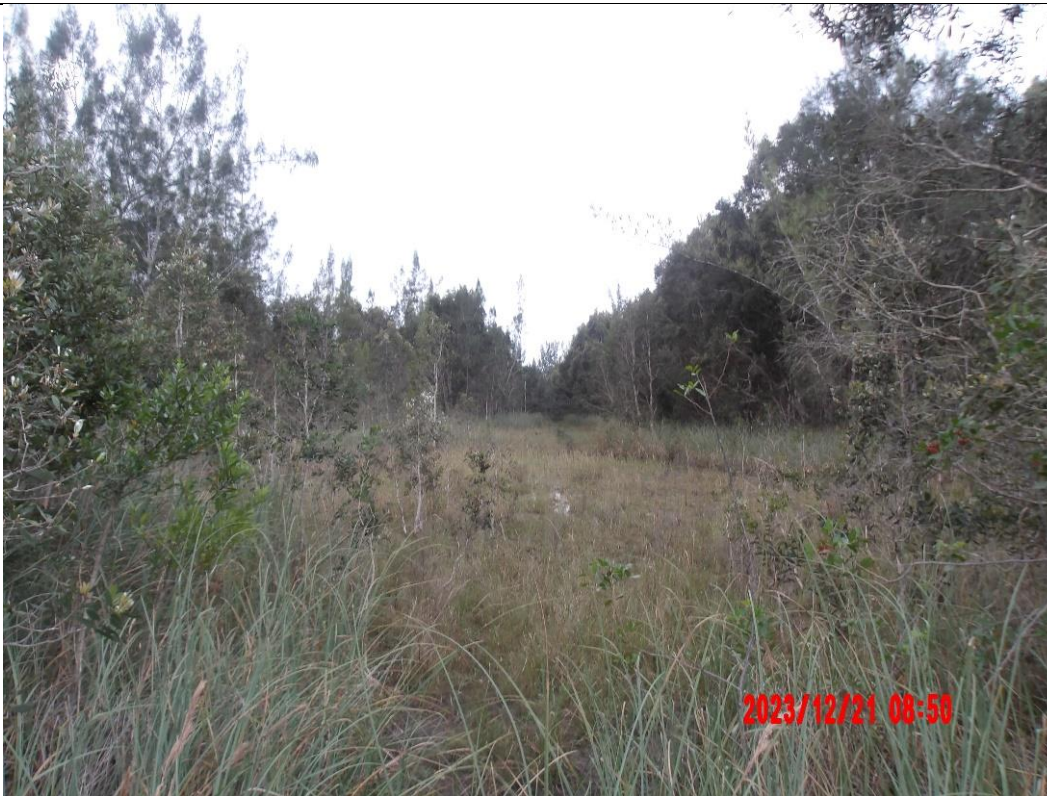
Photo 3

Description 3: View of the freshwater marsh area. No wading birds were seen in this area. Photo taken at Point E facing south.

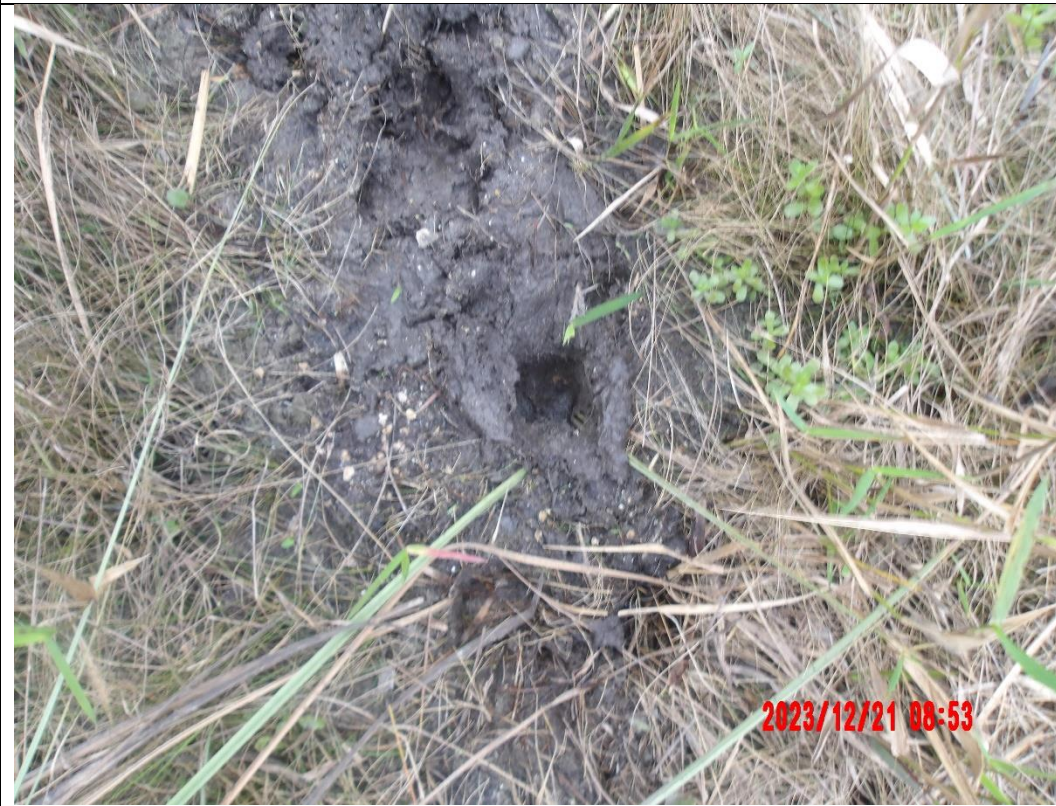
Photo 4

Description 4: View of *Odocoileus virginianus* (white-tailed deer) tracks. Photo taken near Point E.

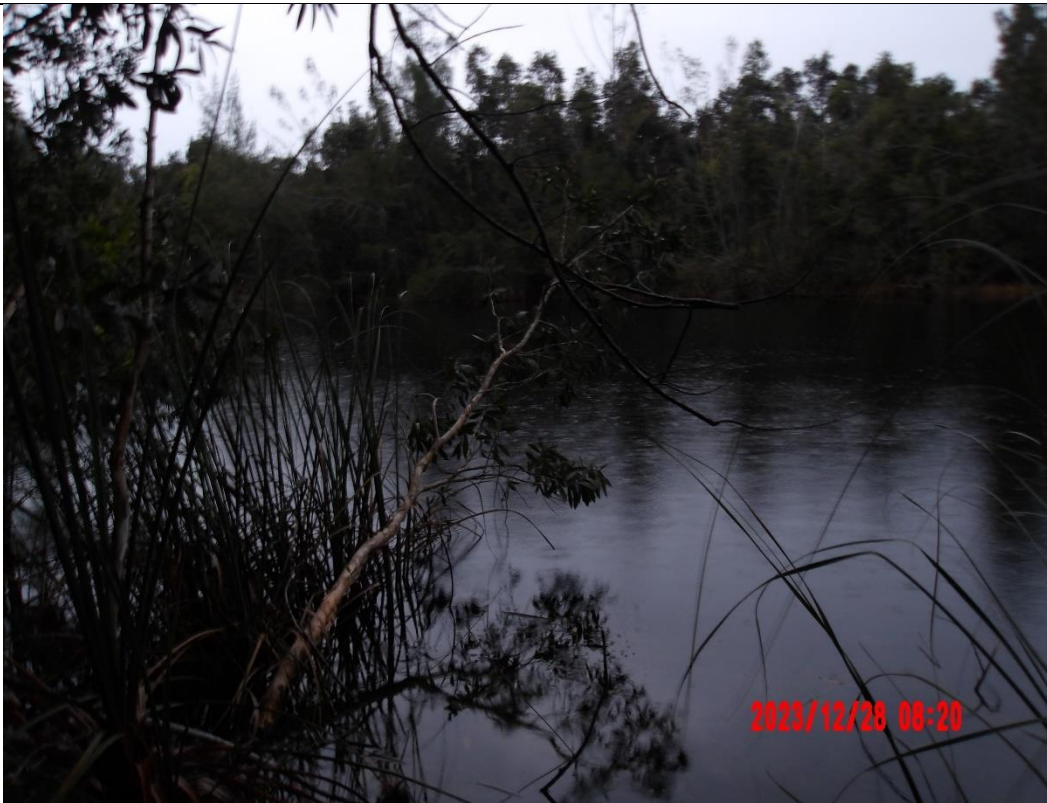
Photo 1

Description 1: View of Point A (Refer to photo 10 for the location). No wading birds were seen in this area. Photo taken facing North.

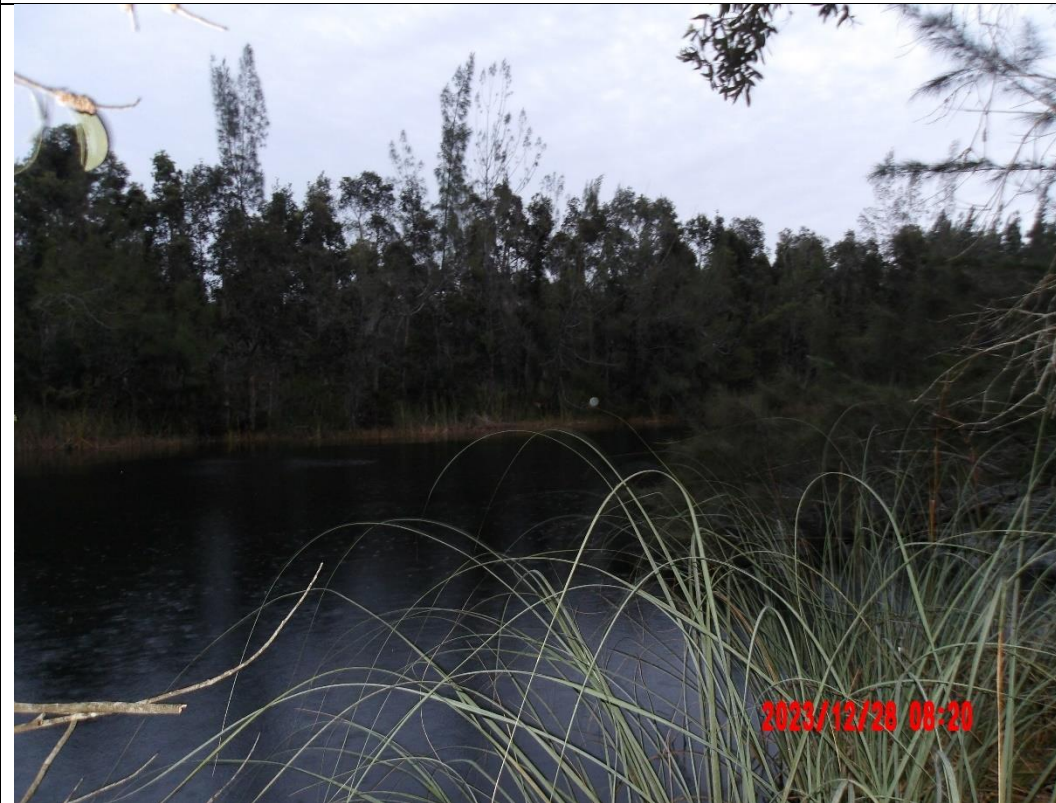
Photo 2

Description 2: View of Point A (Refer to photo 10 for the location). No wading birds were seen in this area. Photo taken facing North.

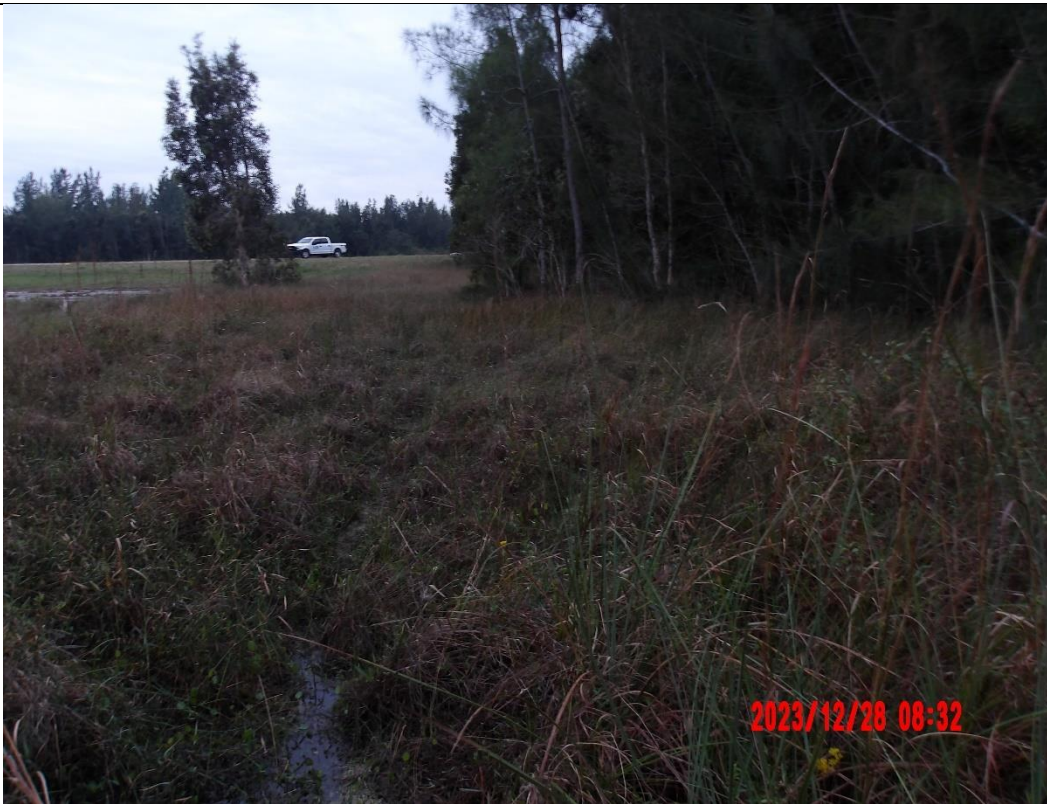
Photo 3

Description 3: View of entrance to Point B (Refer to photo 10 for the location). No wading birds were seen in this area. Photo taken facing North.

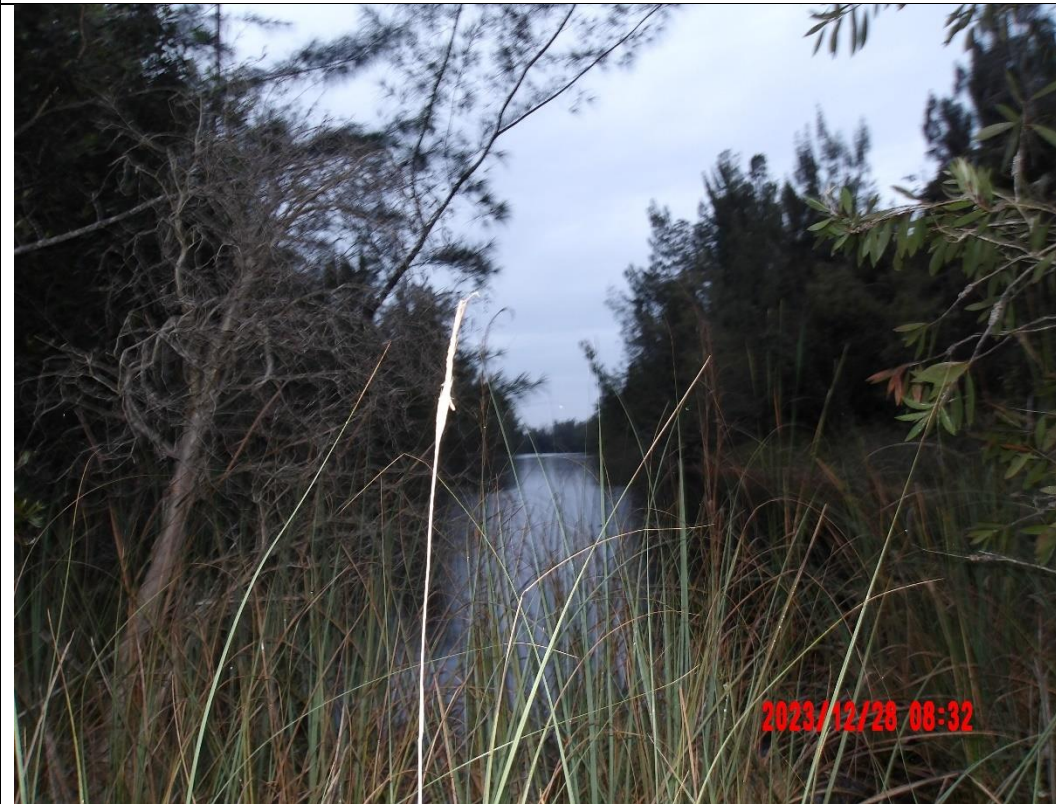
Photo 4

Description 4: View of Point B (Refer to photo 10 for the location). No wading birds were seen in this area. Photo taken facing West.

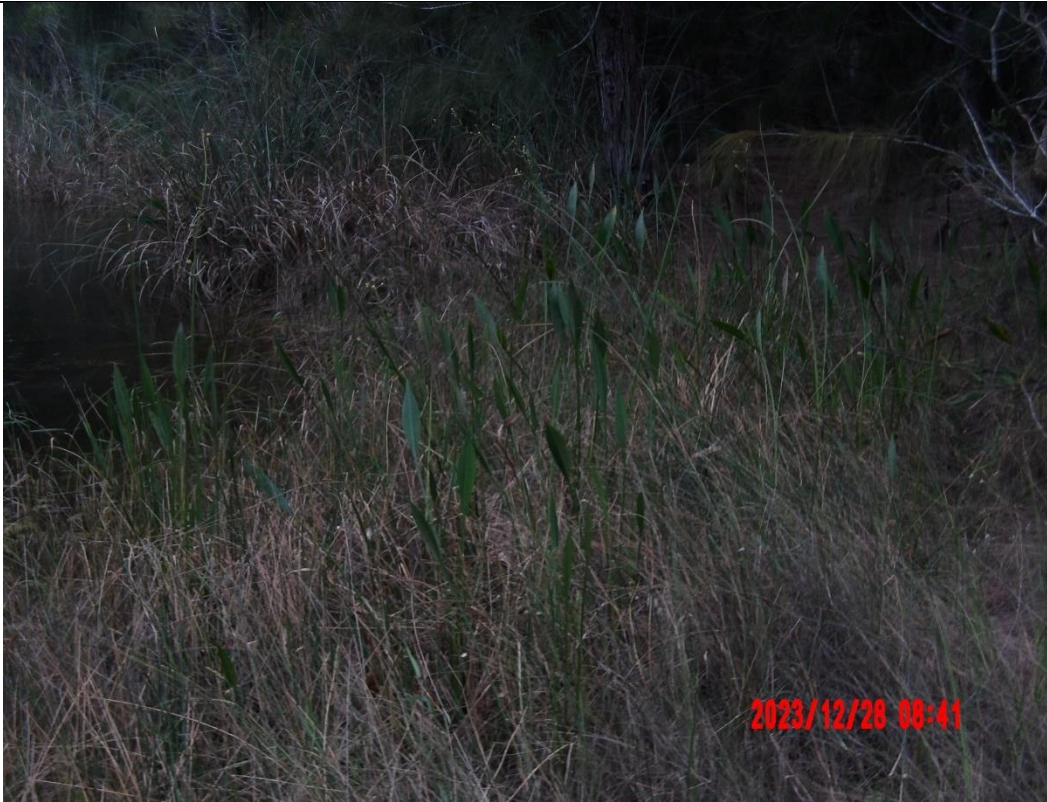
Photo 5

Description 5: View of the littoral area at Point C (Refer to photo 10 for the location).
No wading birds were seen in this area. Photo taken facing North.

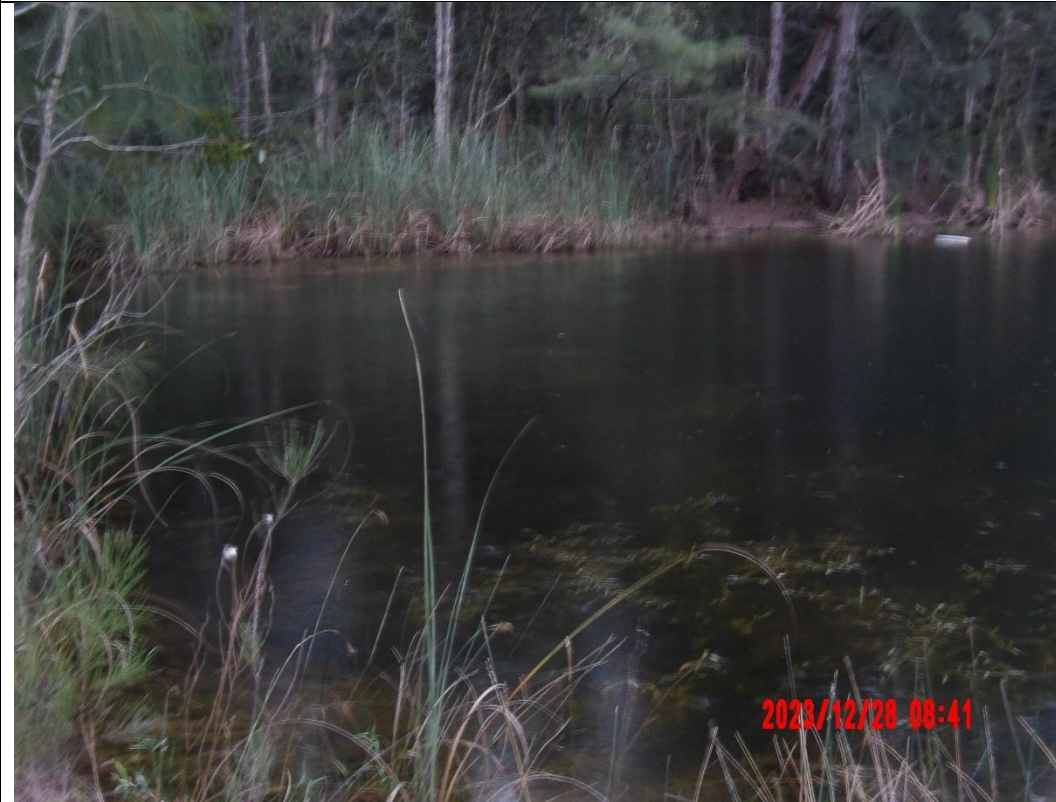
Photo 6

Description 6: View of Point C (Refer to photo 10 for the location). No wading birds
were seen in this area. Photo taken facing North.

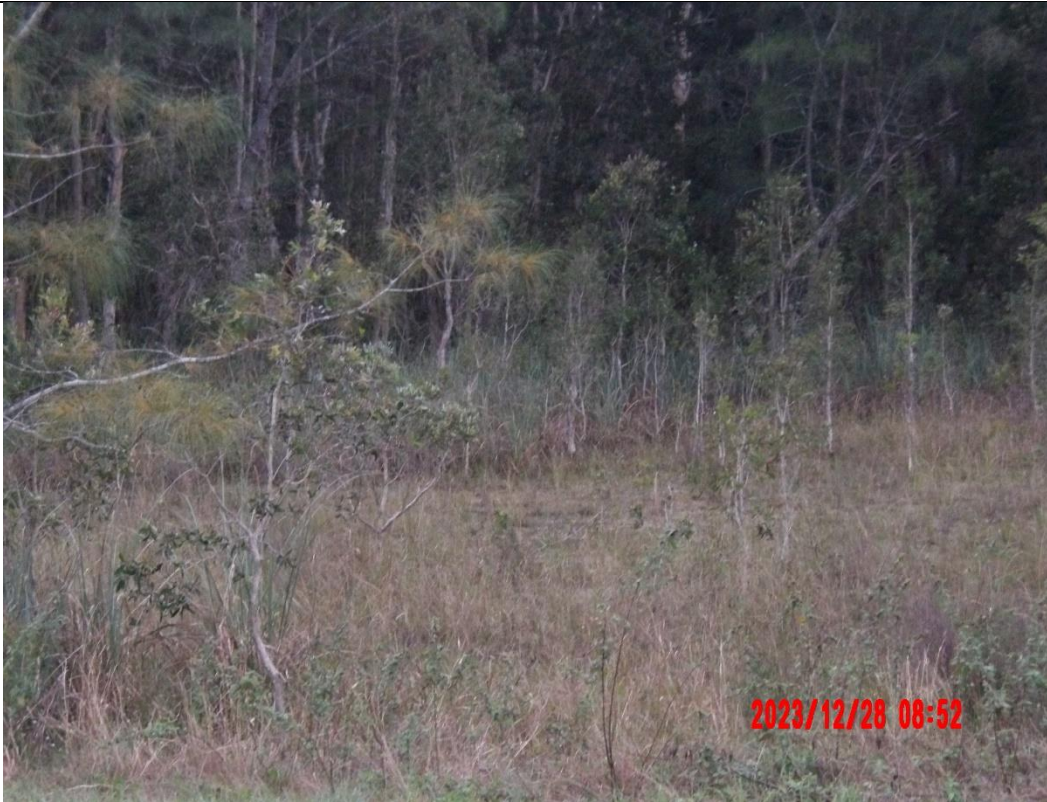
Photo 7

Description 7: View of point E (Refer to photo 10 for the location). An *Ardea Herodias* (great blue heron), and a *Charadrius vociferus* (killdeer) were found in this location. Photo taken facing south west.

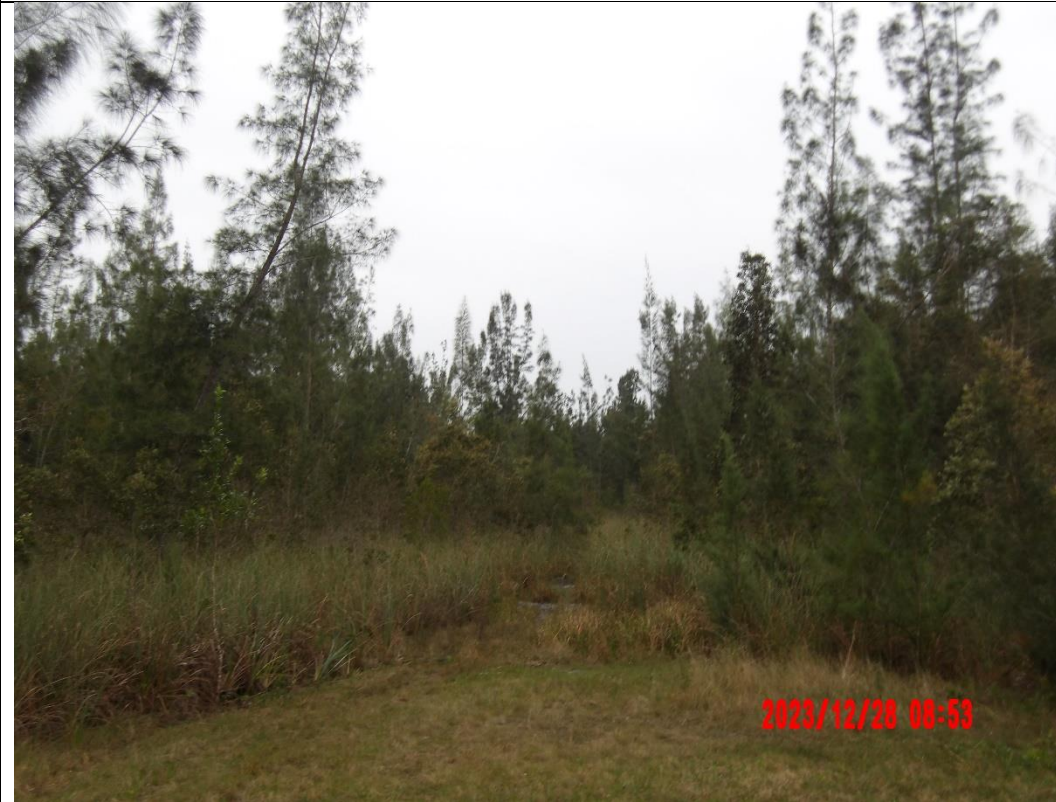
Photo 8

Description 8: View of point E (Refer to photo 10 for the location). An *Ardea Herodias* (great blue heron), and a *Charadrius vociferus* (killdeer) were found in this location. Photo taken facing south east.

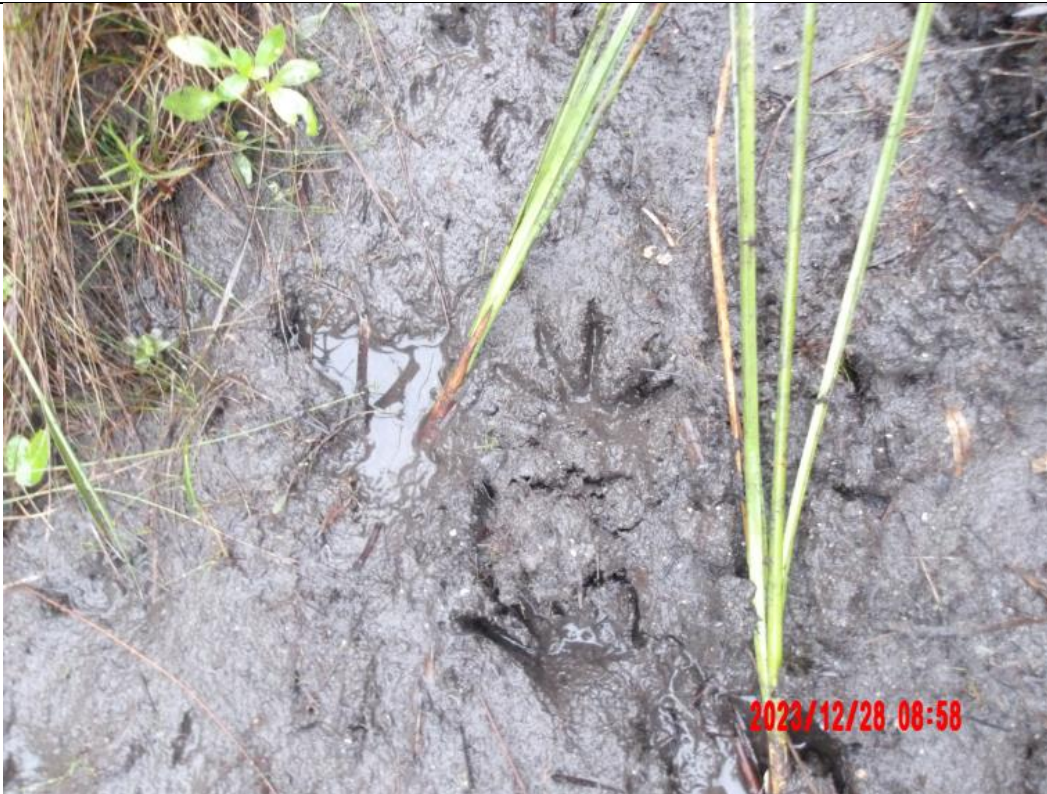
Photo 9

Description 9: View of prints made by *Procyon lotor* (North American Raccoon) found in point E (Refer to photo 10 for the location).
